Study of the effect on manufacturing parameters on the fatigue behavior of aluminum engine mounting bracket

Hossein Khalajzadeh¹, Seyed Vahid Hosseini^{*1}, Alireza Shaterzadeh¹

¹Faculty of Mechanical Engineering, Shahrood University of Technology, Shahrood, Iran.

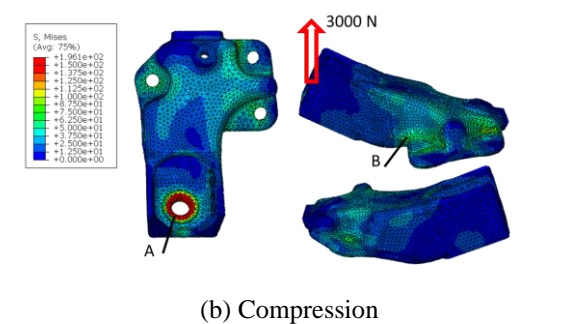
Figure 4 shows the modeled sample in finite elements software under tensile and compressive loading. According to Figure 4 and Table 5, the location of stress concentration points and the amount of displacements in these two cases indicate very good agreement. Based on the results, three critical regions were identified, that the most critical state is A and the least dangerous area is C. But in the fatigue test results, the sample fails at location C.

Figure 4. Finite element modeling of the part.

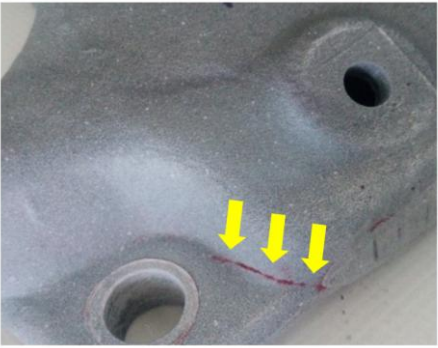
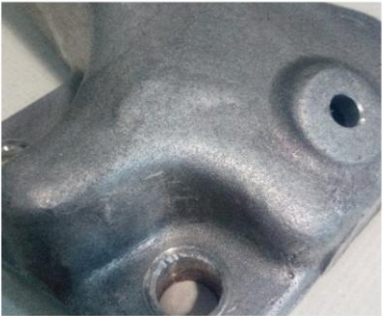
The reinforcement of the connection area of the base to the wall in the modified sample has led to the removal of the crack in this area. In order to make a more detailed investigation, after the completion of the fatigue test, a comparison of the primary and secondary samples was made by conducting a penetrating liquid test. Also, after fixing the manufacturing parameters to cause the cracks in the part, by repeating the high-cycle fatigue test on the modified sample, the crack moved from the connection area of the base to the wall to the end area of the part, as shown in Figure 11. This means that similar to the finite element results in the modified sample, the most critical region is located at point A. Table 9 shows the improvement of the modified sample respected to primary sample. As observed, the resistance of modified sample increased by 7% and scatter of fatigue results has decreased by 14%.

Figure 11. a) Identification of the crack in the front area of the primary sample. b) Removal of the crack in the front area of the modified sample. c) Appearance of a crack in the end area of the modified sample.
