Experimental and analytical investigation of dynamic crack patterns in automotive windshield sheets subjected to low velocity impact

Abstract

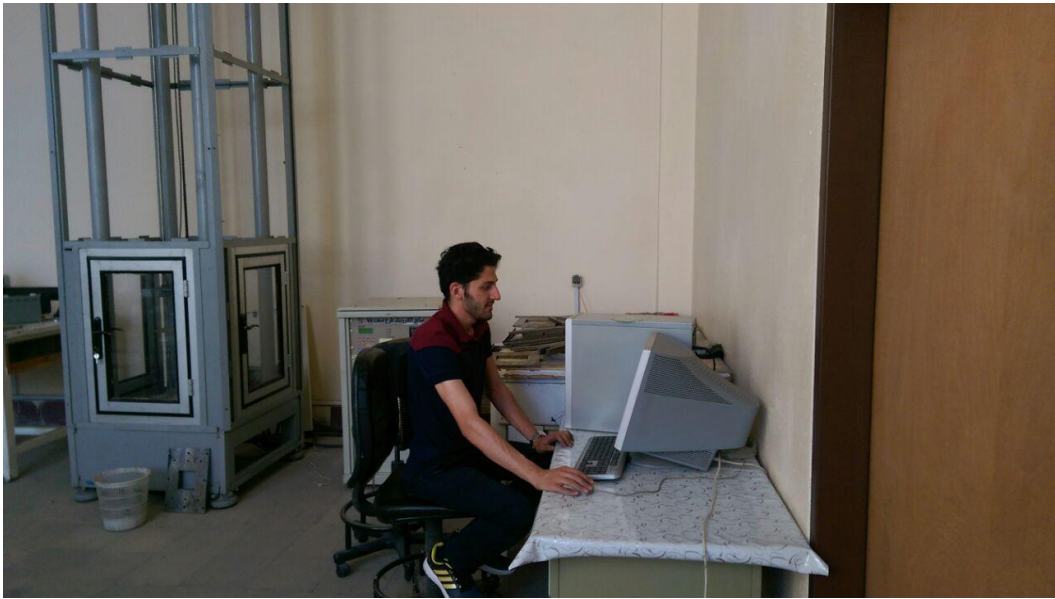
Fig1.Drop ball test machine used for experimental tests

The experiments were conducted on a drop ball testing machine (shown in Fig.1) equipped with accelerometer to investigate the laminated glass temporal response after the impact of a hard sphere. Some other specifications of the machine are shown in Table 1.

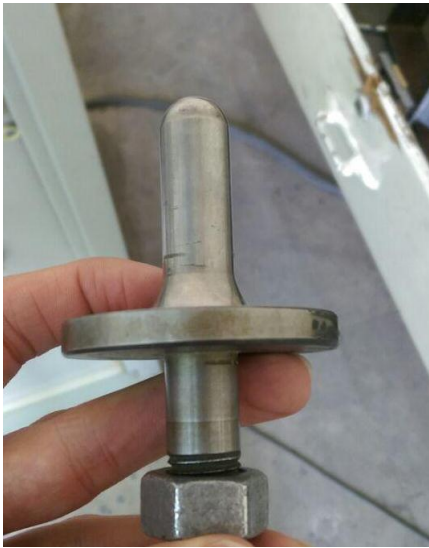
Fig2.Steel imp actor used in drop ball tests

The geometrical and mechanical properties of the impactor (which is depicted in Fig.2) are explained in Table 2.

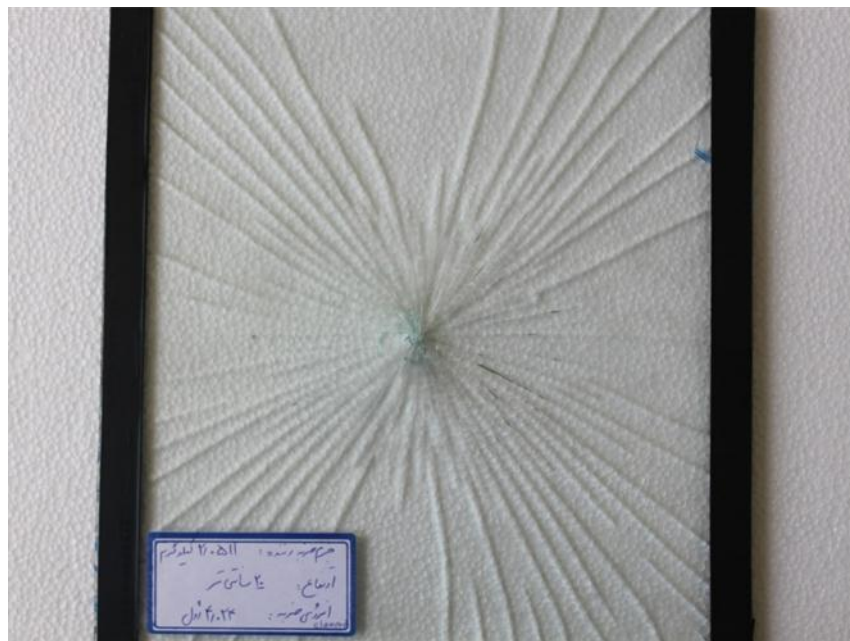
Fig4..specimen after test code D-B-T-1

Laminated glass specimen after test code D-B-T-1 is shown in Fig.4.

As it is observed from Fig.4, the impact region at the center of specimen is a circle with approximate diameter of 3mm. Indeed, due to low energy of impact, the impactor has not caused remarkable damage at the impact area. In addition, the impactor has not penetrated in the specimen and damage is superficial. As a matter of fact, the impact energy has been released through radial cracks propagation and the impactor has not had any penetration in the specimen.

It can be inferred from Fig.4 that the radial cracks in test code D-B-T-1 are nearly symmetrical and about 67 from which this quantity, 60 cracks have been extended to the borders of specimen and released their energy

through reaching the boarder pf specimen. As a consequence, the damage mode is dynamic crack propagation. In this specimen, no circumferential crack is observed which can be due to low level of impact energy. Consequently, it seems that although all the impact procedure occurs in less than some milliseconds, radial cracks are made at the first stage. At the vicinity of impact region, some sectors of circles are observed which are distributed sporadically to the approximate radius of 6mm from the center of specimen. Moreover it can be seen from Fig.4 that the radial cracks have been propagated from the impact surface of laminated glass. On the other hand, the radial cracks in this specimen are superficial and have not reached the lower surface of specimen, hence it can be understood that the fracture of laminated glass begins with superficial cracks at the upper surface of specimen.

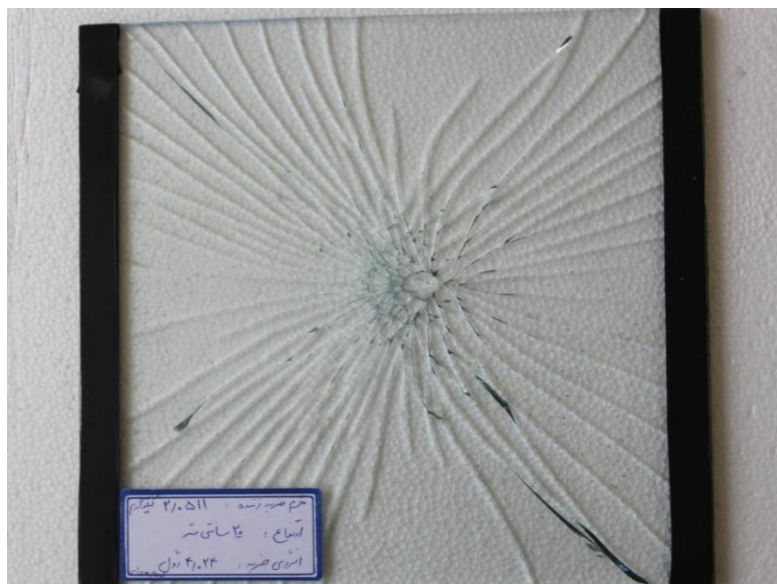
Fig6. specimen after test code D-B-T-2

Laminated glass specimen after test code D-B-T-2 is shown in Fig.6

Like test code D-B-T-1, no circumferential crack is observed at the specimen. The results of this test are akin to the test code D-B-T-1, just 2 differences are observed:

There are 62 radial cracks which is five number less than test code D-B-T-1.

The damage region at the center of specimen in test code D-B-T-2 is a bit larger than the counterpart region in test code D-B-T-1.

Indeed, some part of failure mode has been transformed to powdering failure mode.

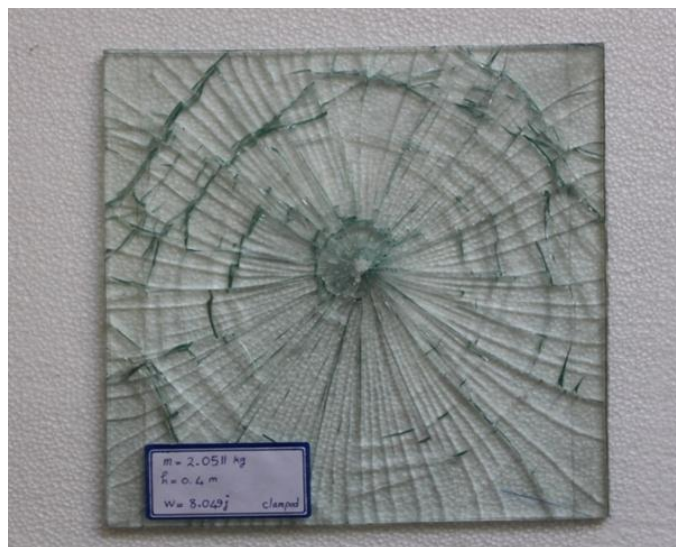
Fig10. .specimen after test code D-B-T-4

Laminated glass specimen after test code D-B-T-4 is shown in Fig.10.

As it is observed from Fig.10, the impact region at the center of specimen (powdering region) is a circle with approximate diameter of 20mm in which cracks density and consequently damage level is higher than the other regions of specimen. The projectile has penetrated to the depth of 1-1.5mm of the laminated glass and due to 2.5mm thickness of glass layers, no elongation has been occurred in PVB interlayer. Although energy level of test code D-B-T-4 is higher than test code D-B-T-3's one, penetration at the center of specimen is less in test code D-B-T-4 which

It is easily seen from test code D-B-T-4 specimen that cracks have initiated from the impact surface and propagated through thickness. In this test, one circumferential crack has been propagated which is at the radius of 95mm from the center. Besides, some sectors of circumferential cracks have been made at the

radiuses of 62, 70 and 80mm from the center of specimen and serve as bridges to connect radial cracks. Also it can be seen from the laminated glass that the radial cracks in test code D-B-T-4 are nearly symmetrical and about 84. After drawing a comparison between test code D-B-T-4 and test code D-B-T-3, it is obvious that radial cracks of test code D-B-T-4 are more than their counterparts in test code test code D-B-T-3, on the other hand circumferential cracks of test code D-B-T-3 are more than test code D-B-T-3's ones. At test code D-B-T-4, distance between radial cracks is shorter than its corresponding item in test code D-B-T-3.

At all 4 sides of specimen which was clamped during the test, diagonal asymmetrical

net shaped cracks have been made which have created some right triangles in margins of the specimen. Diagonal net shaped cracks at the margins of test code D-B-T-4 specimen are more congested in comparison to the whole radial cracks. In addition, at both upper and lower glass layers, radial cracks converge at the center of the specimen and their divergence increases at larger radiuses. The acceleration versus time graph of test code D-B-T-3 is illustrated in Fig.11. As it can be seen from the graph, the maximum acceleration imposed to projectile is 732.0356 m/s^2 which is occurred at 0.000131s.

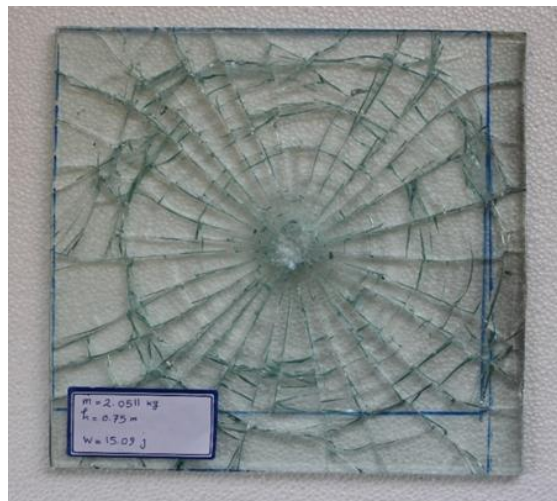
Fig12. .specimen after test code D-B-T-5

Laminated glass specimen after test code D-B-T-5 is shown in Fig.12.

As it is observed from Fig.12, the impact region at the center of specimen (powdering region) is a circle with approximate diameter of 20mm in which cracks density and consequently damage level is higher than the other regions of specimen. The projectile has penetrated to the depth of 4mm of the laminated glass, indeed the upper layer glass has fractured and PVB interlayer has elongated, but no tearing is observed. At the center of test code D-B-T-5 laminated glass, penetration depth has increased in comparison to test codes D-B-T-4 and D-B-T-3. Total number of circumferential cracks of the specimen is 5 which are placed at 47, 70, 80, 90 and 105mm distance from the center. At the vicinity of borders (close to clamping spots), net shaped diagonal cracks are more congested. Cracks have been propagated from the impact surface of laminated glass. At all 4 sides of the specimen, diagonal asymmetrical net shaped cracks have been made. At both upper and lower glass layers, radial cracks converge at the center of the specimen and their divergence increases at larger radiuses. Most of radial cracks have reached the borders of specimen and released their internal impact energy by this way.

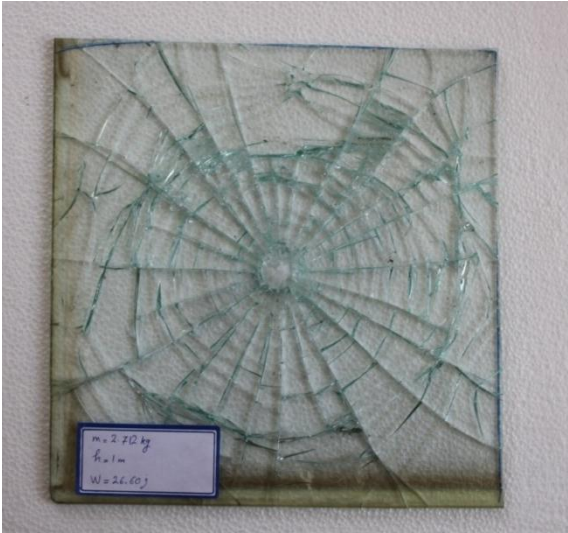
Fig14. .specimen after test code D-B-T-6

Laminated glass specimen after test code D-B-T-6 is shown in Fig.14.

As it is observed from Fig.14, the impact region at the center of specimen (powdering region) is a circle with approximate diameter of 20mm in which cracks density and consequently damage level is higher than the other regions of

specimen. In this test, the projectile has penetrated thoroughly in specimen. Therefore the glass layers have fractured and the PVB interlayer has torn. This test (test code D-B-T-6) has higher impact energy level in comparison to test code D-B-T-5. It can be observed that the penetration at the center of test code D-B-T-6 specimen is deeper than test code D-B-T-5, on the other hand the number of radial cracks is smaller in test code D-B-T-6. In fact, the impact energy has been released mostly through penetration in thickness direction and residual energy has released through radial and circumferential cracks. The radial cracks in test code D-B-T-6 are nearly symmetrical and about 24 which has decreased about 20% in comparison to test code D-B-T-5, but the penetration depth has

There are 6 circumferential cracks in the specimen at the radiuses of 34,41,51,60, 70 and 95mm from the center of the laminated glass sample. It can be seen from Fig.14 that the radial cracks have been initiated from the impact surface of laminated glass and propagated along thickness direction. In one side of the laminated glass, sectors of circumferential cracks like grids, have connected radial cracks to each other. 12 out of total 24 radial cracks have extended to the borders of the specimen and released their internal impact energy by this way. The acceleration versus time graph of test code D-B-T-6 is illustrated in Fig.15
