FATIGUE BEHAVIOUR OF A ROLLED AZ31 MAGNESIUM ALLOYS PREPARED BY EP AND BB CONDITIONS

Abstract: Rotating bending fatigue tests have been performed using smooth specimens of a rolled AZ31 magnesium alloy in laboratory air at ambient temperature. Fatigue strength and characteristic was evaluated and fracture mechanism was discussed on the basis fracture surface analysis. Electrical polishing (EP) as well as deep rolling (ball burnishing (BB)) U-notched specimens were performed on two groups of samples, to evaluate optimum conditions for fatigue life. The microstructure and tensile properties of roll cast (RC) Mg- 3% Al- 1% Zn (AZ31) was investigated. The fatigue strength of 107 cycles around 100 MPa for deep rolling while it was around 40 MPa for Electrical polishing. It was very important to understand the effect of (ball burnishing (BB)) conditions on the hardness of the surface through to the core. The two procedures improved the fatigue performance, but better improve in results were found in ball burnishing. The growth of small cracks initiated at the surface coincided with the FCP characteristic after allowing for crack closure for large cracks, but the operative fracture mecha

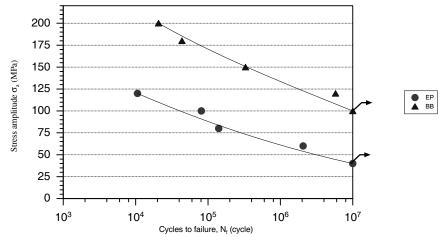
Fig.2. S-N curve for rolled AZ31 at EP,BB conditions, rotating beam, R=-1, 50Hz.

S/N curves for the EP and the BB specimens in laboratory at a stress ratio of -1 and frequency of 50 Hz (rolled magnesium alloy) in laboratory air is shown in Fig. 2. In this figure, for comparison purposes, the S-N curves of the EP and BB specimens are shown respectively. As seen from the figure, the fatigue life of the rolled magnesium alloy of EP specimen is relatively shorter than that of BB specimen. The extent bending in the S-N curve is gentler in the BB specimens than in the EP specimen. Next let us compare the S-N characteristics of the EP and BB specimens. There are great differences in the fatigue lives and in the fatigue limits, especially at higher stress amplitudes, there are differences in the fatigue lives.

The fracture surface of AZ31 for EP condition and BB condition at different stress is shown in Fig. 4. Subsurface crack initiation occurred at applied stresses at 60 MPa. At BB condition but it can be seen for both 80 and 100 MPa stress for EP condition. The S–N diagram is shown in Fig. 2. It is well known that fatigue limit does not exist in non-ferrous alloys, thus fatigue tests were continued until 10⁷ cycles. At EP condition σ = 40 MPa, fatigue failure did not occur, but non-propagating cracks were observed on the specimen surface. As can be seen in the figure, the present Mg alloy seems to possess a definite fatigue limit, which may be related to the existence of non-propagating cracks. The fracture mode depending

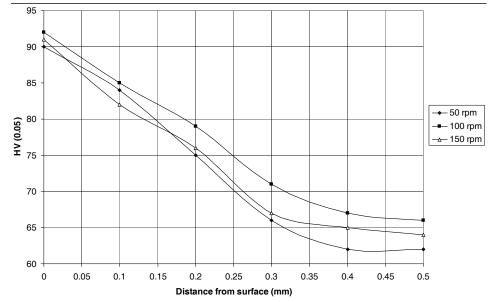
Fig. 3. Microhardness profile oif AZ31 after BB at 200 bars, 0.17 mm/min at different BB rotation speed.

3. 3. A different experiment were used to investigate the best condition for BB (pressure, feed rate, speed) as example for tool HG3 200 bar (123 N) for 50, 100 and 150 rpm. The microhardness measurement from the surface in Fig. 3. Shows that the suitable condition for using 200 bars is 100 rpm for AZ31 as the hardness decreased from the circumference gradually to the center.
